Atteberry Home Inspections LLC

Your Property Inspection

**Property address: 123 A Street
Norman, OK 73071**

Inspection date: Monday, June 18, 2018

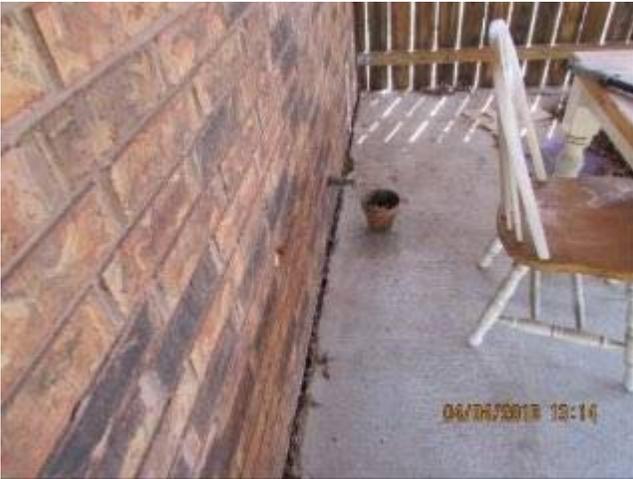
Photo 1-1

Large crack developed between house and back porch slab.

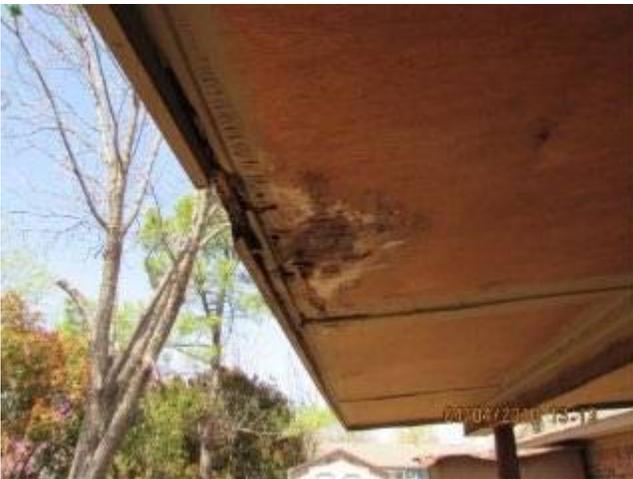
Photo 2-1

One or more deck, patio and/or porch covers were deteriorated. Recommend that a qualified person repair or replace as necessary, and per standard building practices.

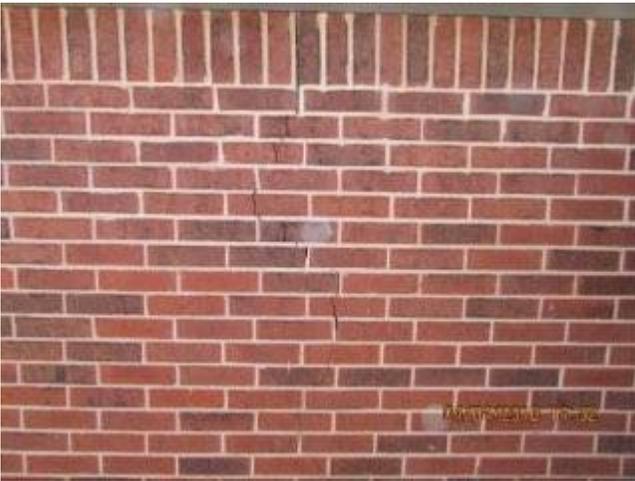
Photo 4-1

Major cracks or areas with damage were found in the masonry (brick or stone) veneer. This may indicate that settlement has occurred and/or that the foundation has failed. At a minimum, a qualified contractor should repair the damaged masonry veneer to prevent water from entering wall cavities and causing mold, fungal rot or structural damage. Consult with a qualified engineer to determine if foundation repairs are needed, and/or if settlement is ongoing. Any such repairs should be made by a qualified contractor. Such contractors and engineers may include:

- Foundation repair contractors who may prescribe repairs, and will give cost estimates for prescribed repairs
- Masonry contractors who repair and/or replace brick veneer
- Geotechnical engineers who attempt to determine if settlement is ongoing, and the cause of the settlement
- Structural engineers who determine if repairs are necessary, and prescribe those repairs

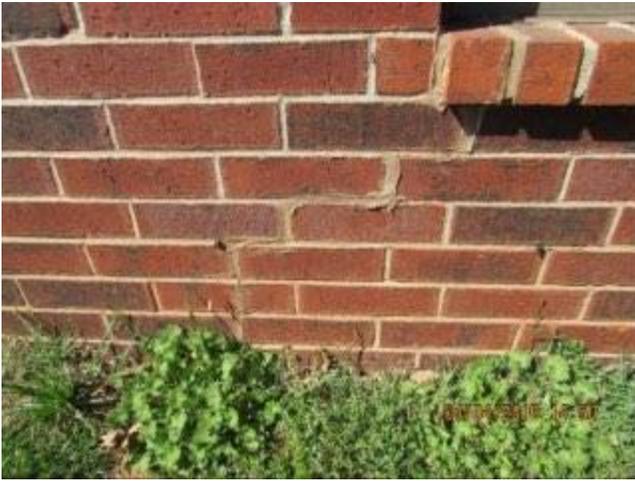
Photo 5-1

The masonry (brick or stone) veneer was deteriorated or damaged in some areas. Where cracks or openings are exposed, water can enter the wall structure causing mold, fungal growth and structural damage. This is a conducive condition for wood-destroying organisms. Recommend that a qualified contractor repair as necessary. For example, by repointing mortar or replacing broken or missing masonry.

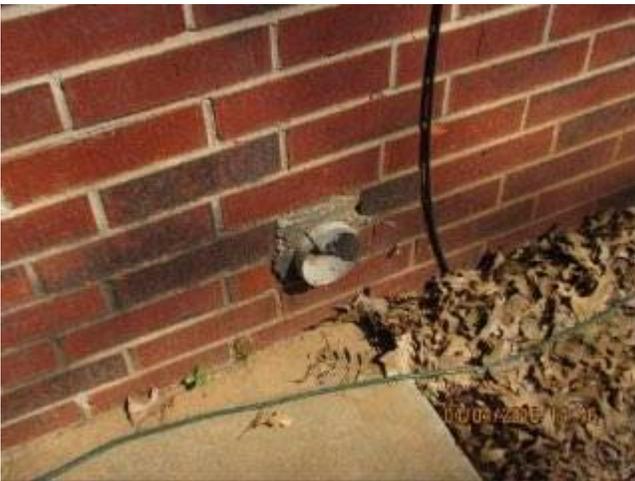
Photo 6-1

One or more exhaust duct end caps were missing. Their purpose is to prevent unconditioned air from entering the building, and keep out birds, rodents and bugs. Blocked ducts can cause fan motors and/or clothes dryers to overheat and can pose a fire hazard. Recommend that a qualified person repair or replace caps as necessary.

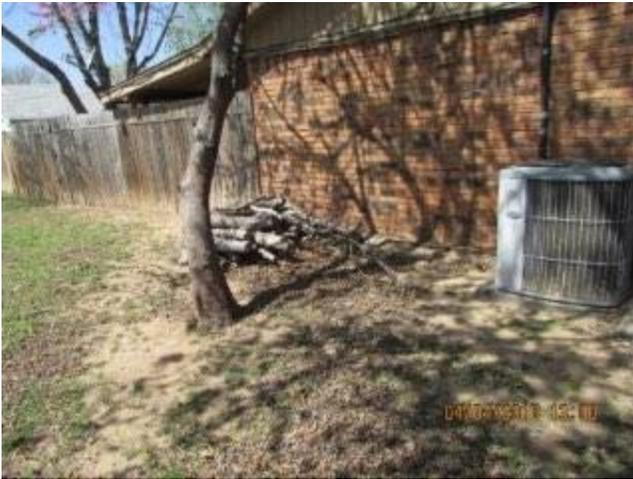
Photo 7-1

Firewood was stored so that it was in contact with or close to the building exterior. This is a conducive condition for wood-destroying organisms. Recommend storing firewood outdoors in an open area, and as far away from buildings as practical to keep insects away from buildings. For more information visit: <http://www.reporhost.com/?FWWDI>

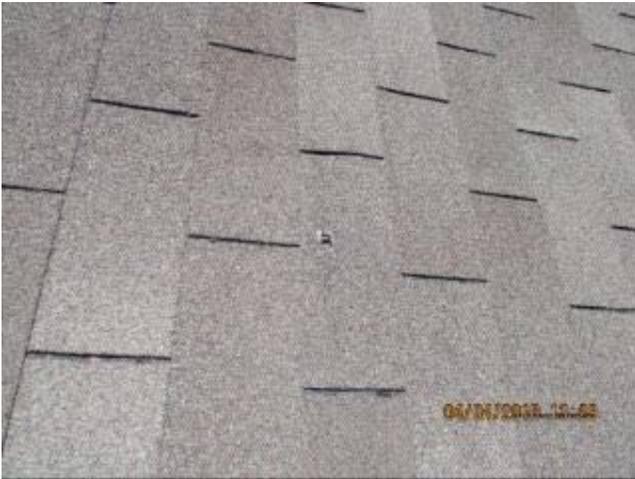
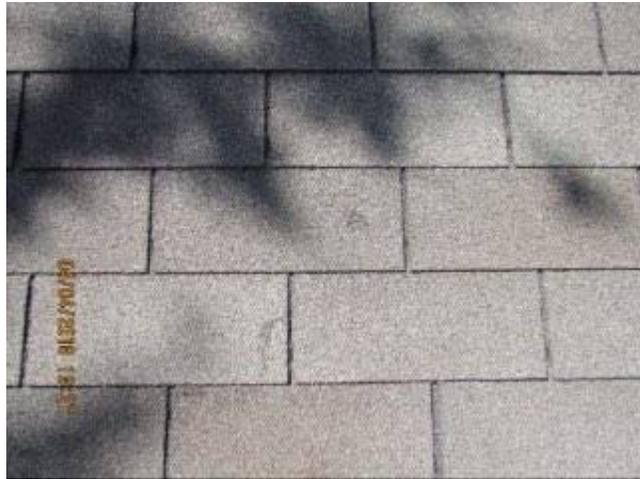
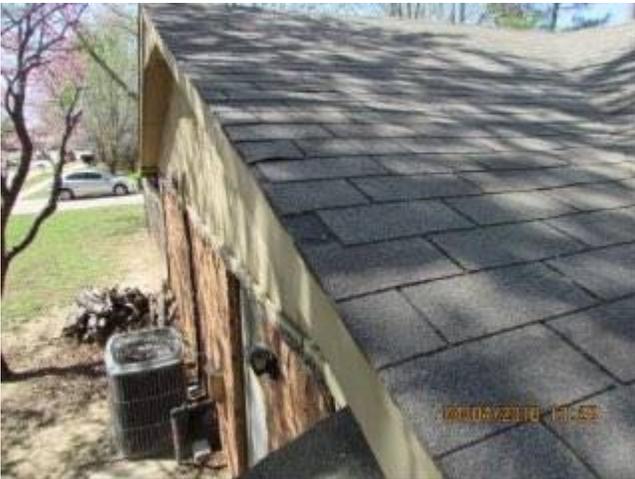
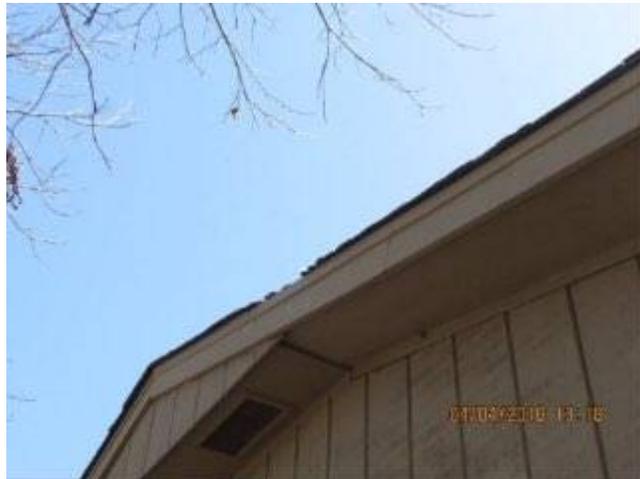
Some composition shingles were cracked, broken and/or damaged. Leaks can occur as a result. This is a conducive condition for wood-destroying organisms. Recommend that a qualified contractor repair as necessary. For example, by replacing shingles.

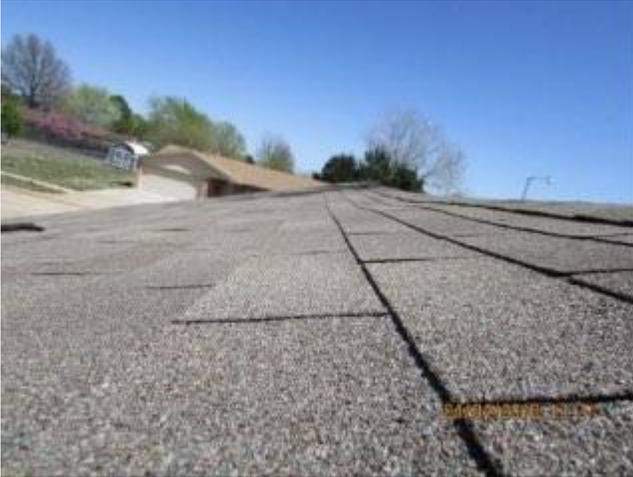
Photo 11-1

One or more roof trusses were cut, damaged or modified. The roof structure has likely been weakened as a result. Trusses are engineered components and shouldn't be cut or modified by builders or homeowners. Repairs may involve restoring the trusses to their original condition or configuration. Recommend that a licensed structural engineer evaluate and prescribe repairs as necessary. A qualified contractor should perform repairs per the engineer's specifications.

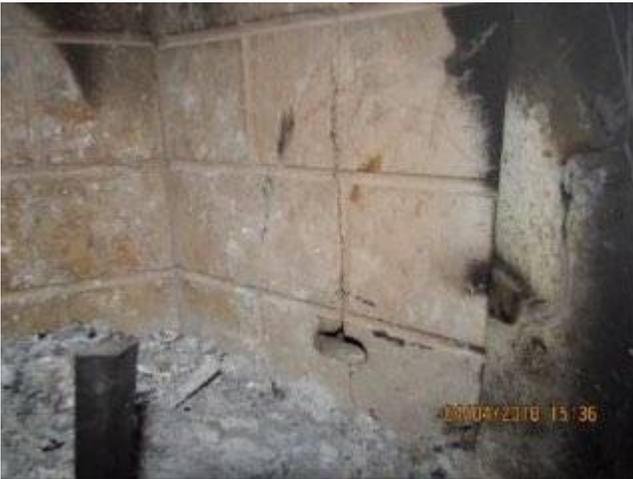
Photo 21-1

Holes or cracks were found in the metal fireplace liner. Fireplaces with metal liners typically circulate indoor air behind the firebox and act as a "heatilator" where warmed air is blown or drawn back into the living area. When holes or cracks form in liners, smoke and combustion gases can enter the heatilator chamber and living spaces. This is a potential safety hazard. Recommend that a qualified specialist evaluate and repair if necessary.

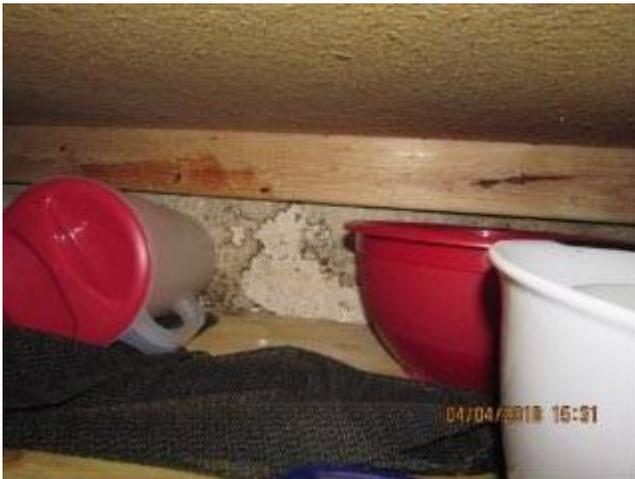
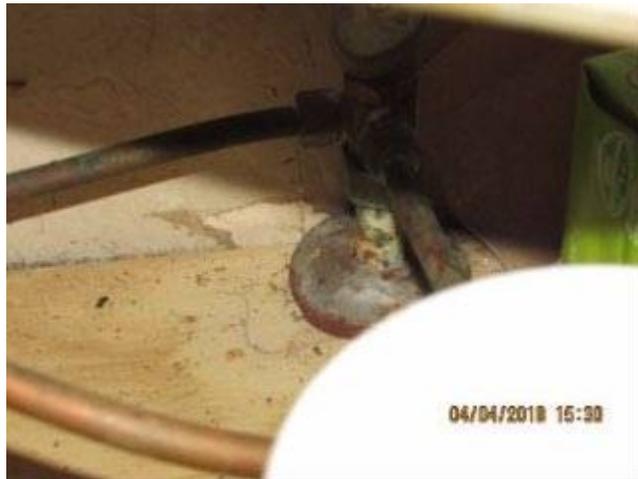
Water damage was found in shelving or cabinets below the sink. Recommend that a qualified contractor repair as necessary after any plumbing leaks have been repaired. If moisture is present then concealed areas should be dried thoroughly.

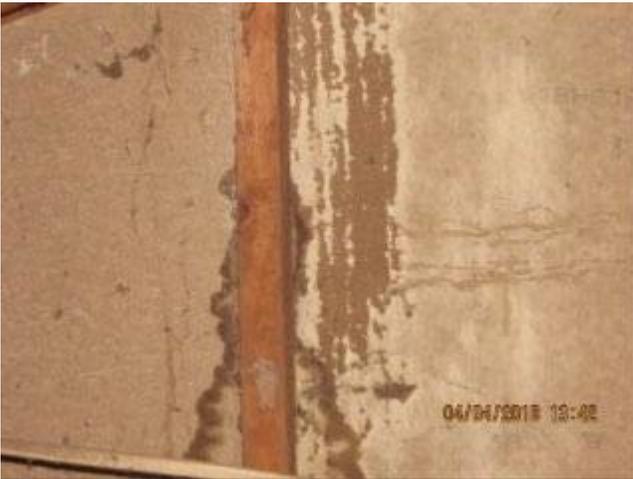
Photo 24-1

Water damage was found in shelving or cabinet components below one or more sinks at location(s) #B. Recommend that a qualified contractor repair as necessary after any plumbing leaks have been repaired. If moisture is present then concealed areas should be dried thoroughly.

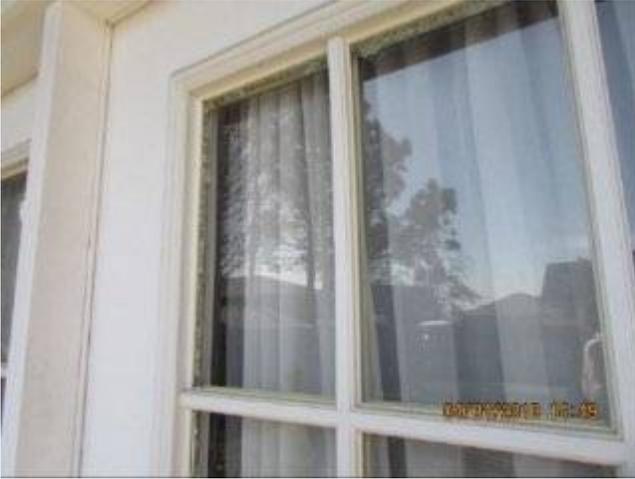
Photo 25-1

Glass in one or more exterior doors was broken. Recommend that a qualified contractor replace glass where necessary.

Double pane safety glass broken. Safety hazard as well as energy lost in heating and cooling.

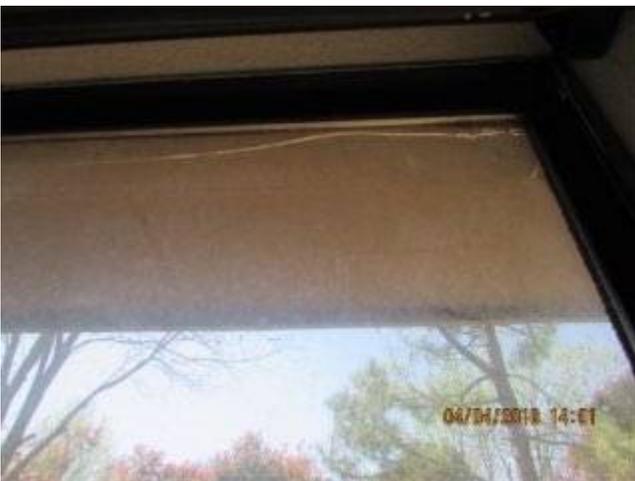
Photo 27-1

Glass in one or more windows was cracked, broken and/or missing. Recommend that a qualified contractor replace glass where necessary.

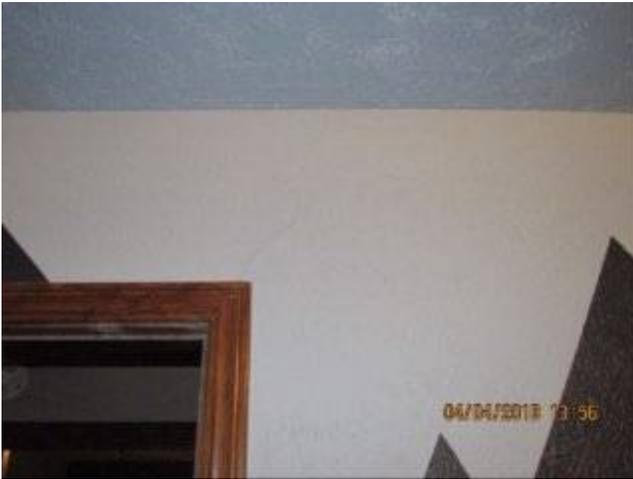
Photo 28-1

One or more walls had substandard repairs. Recommend that a qualified person repair as necessary.

Cracks in walls were caulked and painted over to hide foundational movement.

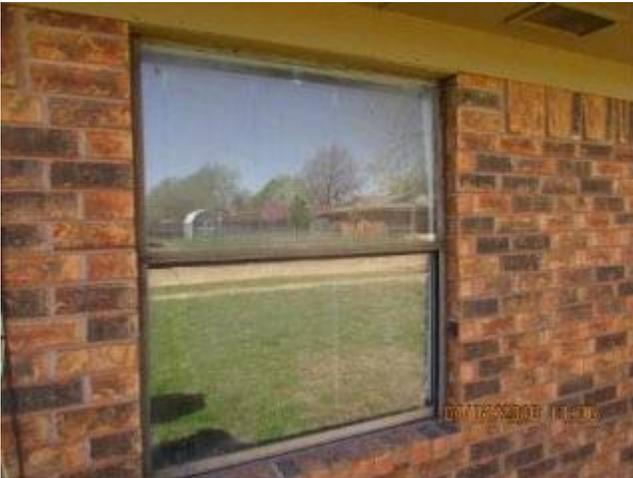
Photo 30-1

30) ⓘ Screens were missing from some windows. These windows may not provide ventilation during months when insects are active.

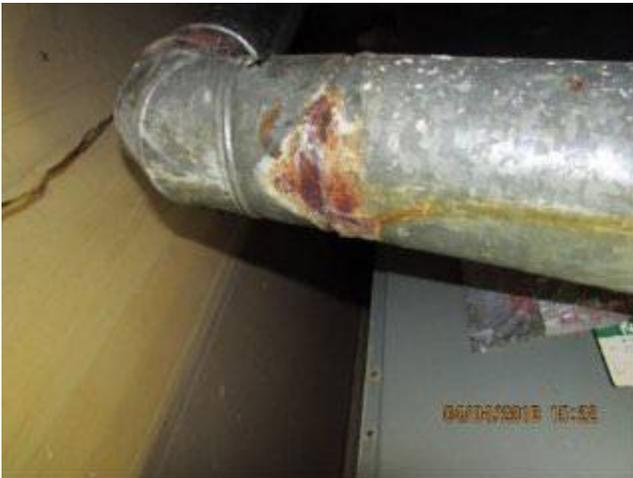
Photo X-1

Water heater vent line shows signs of moisture accumulation. Recommend evaluation by a certified Heat and Air specialist.

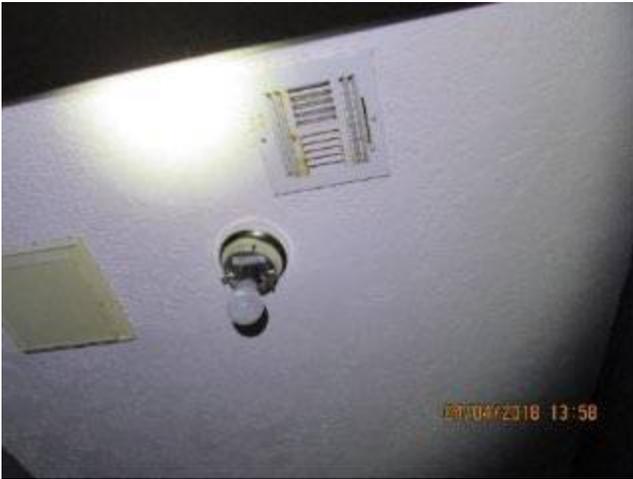
Photo X-3

Interior light fixture missing the globe.
